INDOOR AIR QUALITY ASSESSMENT

**White Brook Middle School
200 Park Street
Easthampton, Massachusetts**

Prepared by:
Massachusetts Department of Public Health
Bureau of Environmental Health Assessment
March 2003

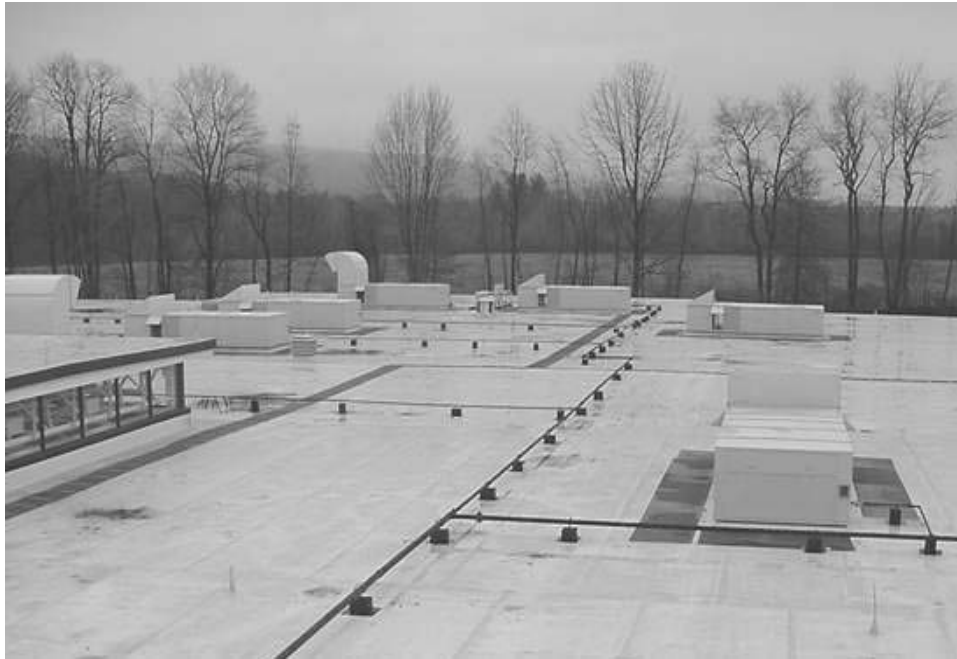
Picture 1

A heating, ventilation and air conditioning (HVAC) system provides ventilation. Fresh air is provided by rooftop-mounted AHUs (see Picture 1). These AHUs are connected to ducts that supply fresh air to rooms through ceiling mounted air diffusers (see Picture 2). By design, air diffusers are equipped with fixed louvers, which direct the air supply along the ceiling to flow down the walls, creating airflow.

Rooftop AHUs

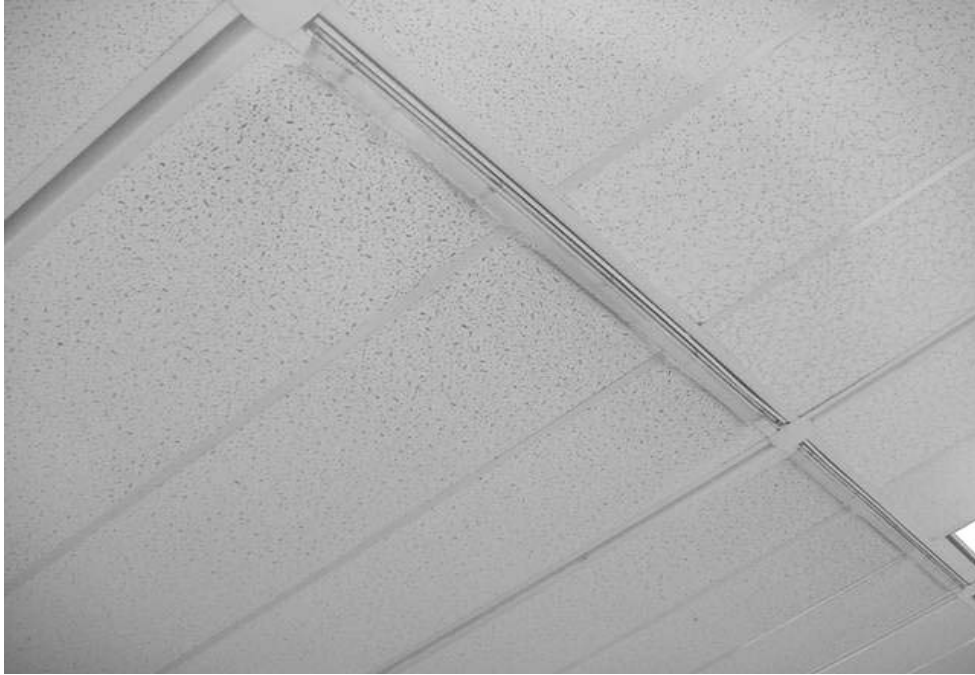
Picture 2

Ceiling Mounted Fresh Air Diffuser

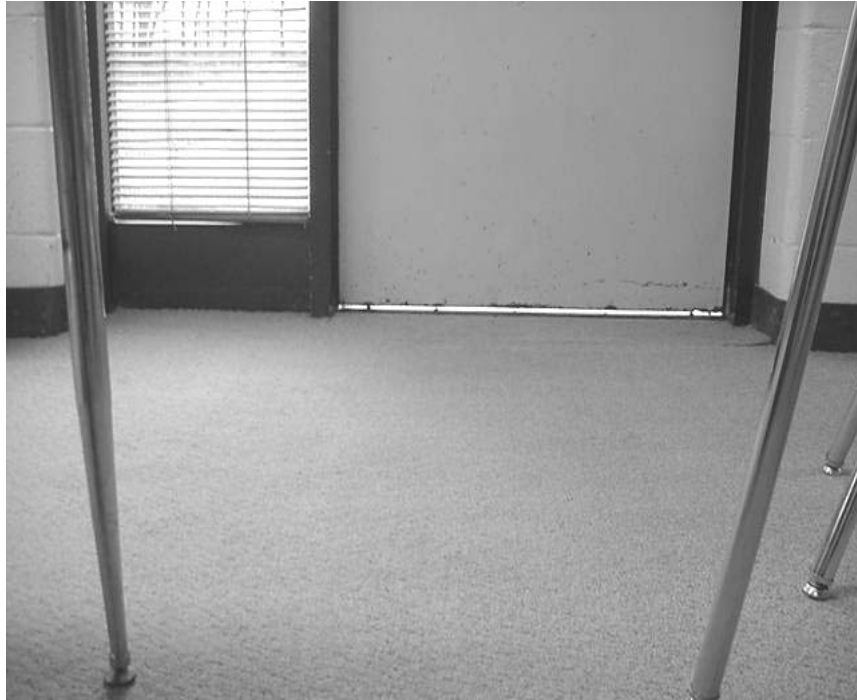
Picture 3

Water penetration was noted through the exterior doorframes of the 500 wing class areas (see Pictures 3 and 4). Similar damage to exterior wall doorframes was noted in other areas of the building. Of note was carpeting in class areas, which was installed against the threshold of exterior doors. Water damage to the doorframes indicates that wall-to-wall carpet installed around the threshold may become regularly moistened, most likely during wind-driven rain or drifting snow. Roof/shelter systems exist over exterior doors. Rainwater collecting on the exterior walls rolls off the wall to the base of the exterior to collect and drain from the building. This design is problematic due to tarmac/cement slabs used as exterior door thresholds. Splashing rainwater can lead to chronic moistening of the exterior wall and doors, which in turn moistens carpet installed against the doorframe. Mold colonization of the carpet can occur from repeated moistening due to driving rain/melting snow. The American Conference of Governmental Industrial Hygienists (ACGIH) recommends that carpeting be dried with fans and heating within 24 hours of becoming wet (ACGIH, 1989). If carpets are not dried within this time frame, mold growth may occur. Water-damaged carpeting cannot be adequately cleaned to remove mold growth. The application of a mildewcide to moldy carpeting is not recommended.

Water Penetration through Door Frame

1. Remove carpeting up to three feet from the threshold of exterior doors. Replace carpeting with a non-slip, nonporous material (e.g., rubber matting, tile, etc.).
2. Examine each AHU, fresh air diffuser and exhaust vent for function. Survey classrooms for univent function to ascertain if an adequate air supply exists for each

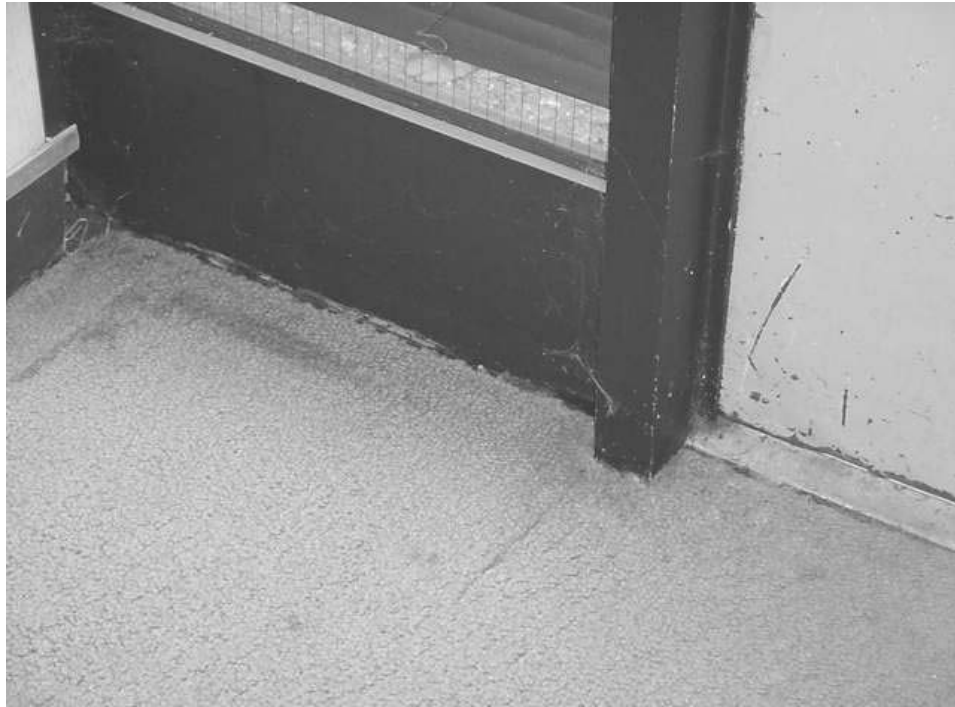
Picture 4

Water Penetration through Door Frame, Note Corrosion at Base of Door and Rust Stain on Carpet

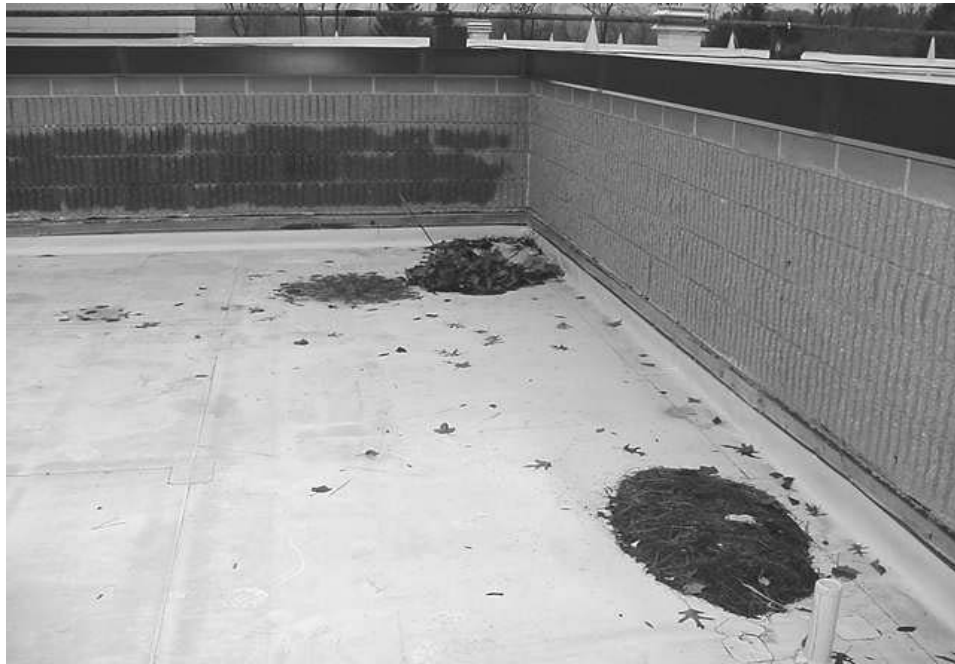
Picture 5

A number of areas have water-damaged ceiling tiles which can indicate leaks from either the roof or plumbing system. One leak over vending machines appears to be a chronic problem. An examination of the roof found a section of roof lower than the majority, which creates a small vertical section of brick wall within the roof (see Picture 5). Spaces in roof flashing seams in brick and mortar joints were noted in this

wall (see Pictures 5 and 6). The spaces in the roof wall correspond to a leak noted above the vending machines.

Vertical Wall on Roof, Note Accumulated Debris

2. Water-damaged ceiling tiles should be replaced. These ceiling tiles can be a source of microbial growth and should be removed. Source of water leaks (e.g., window frames and roof) should be identified and repaired. Examine the non-porous surface beneath the removed ceiling tiles and disinfect with an appropriate antimicrobial.

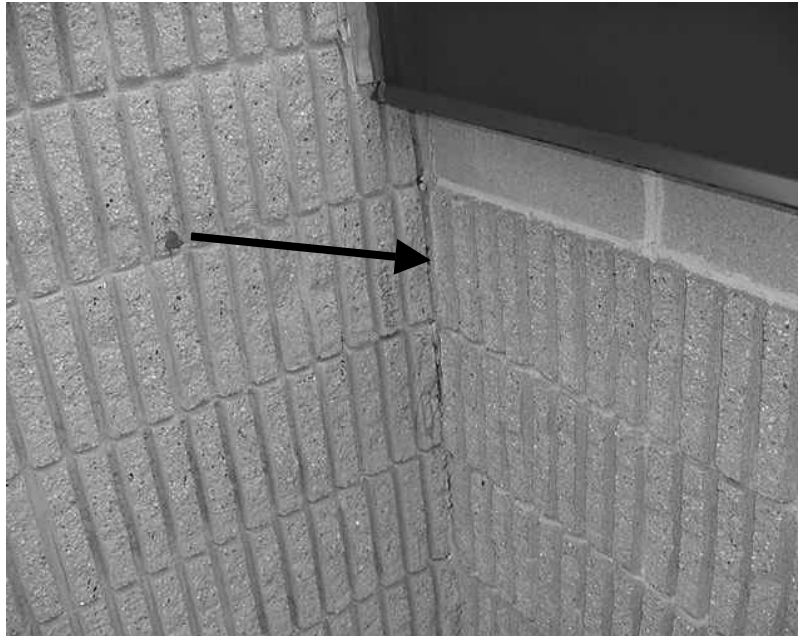
Picture 6

Vertical Wall on Roof, Note Cracks along Seams

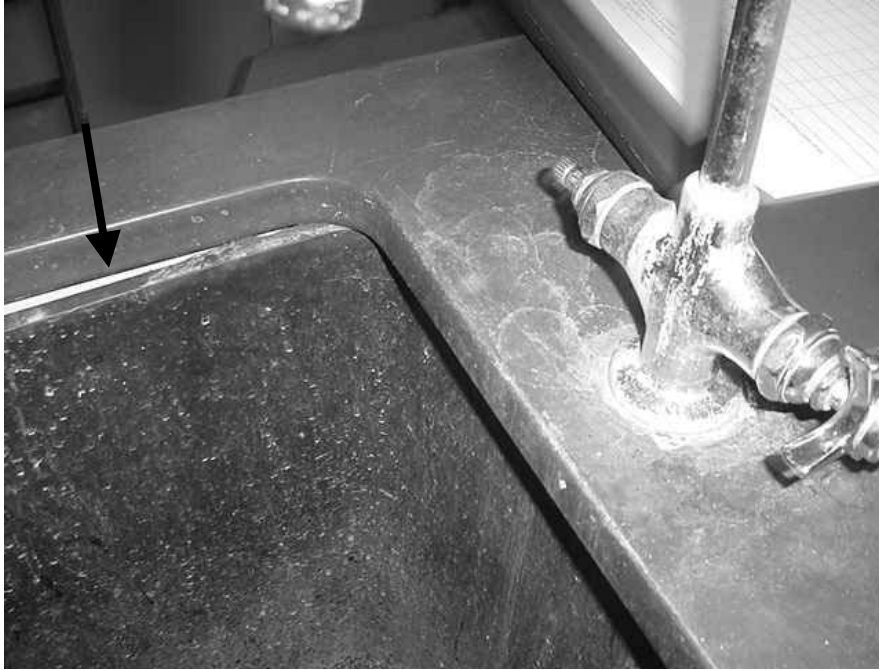
Picture 7

Several classrooms have sinks that had an open seam between the countertop and wall. If not watertight water penetration through this seam can result. Several sinks in the science wing have shifted, opening a space between the counter and sink (see Picture 7). Water penetration and chronic exposure to water on wood and plywood can cause these materials to swell and serve as growth media for mold.

Seam between Sink and Counter

7. Remove foliage to a minimum of five feet away from the foundation.
8. Repair seams between sink countertops and splashboard.
9. Remove debris from roof.

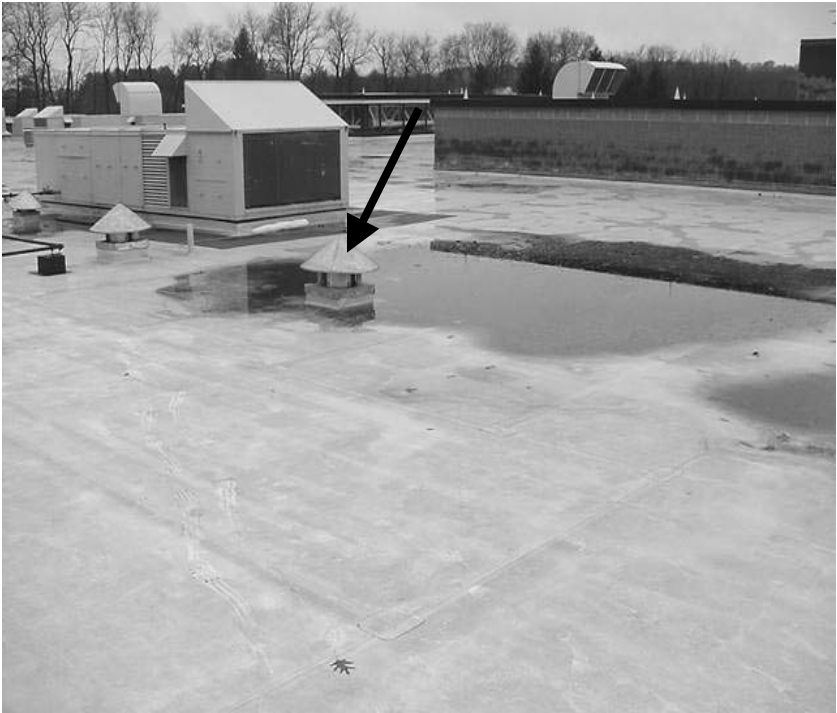
Picture 8

Pools of standing water and accumulated debris (e.g., leaves) were noted in a number of areas on the roof (see Picture 8). The collection of water and the subsequent freezing and thawing during winter months can lead to roof leaks and water penetration

Pooling Water on Roof, Note Contact of Water with Vent

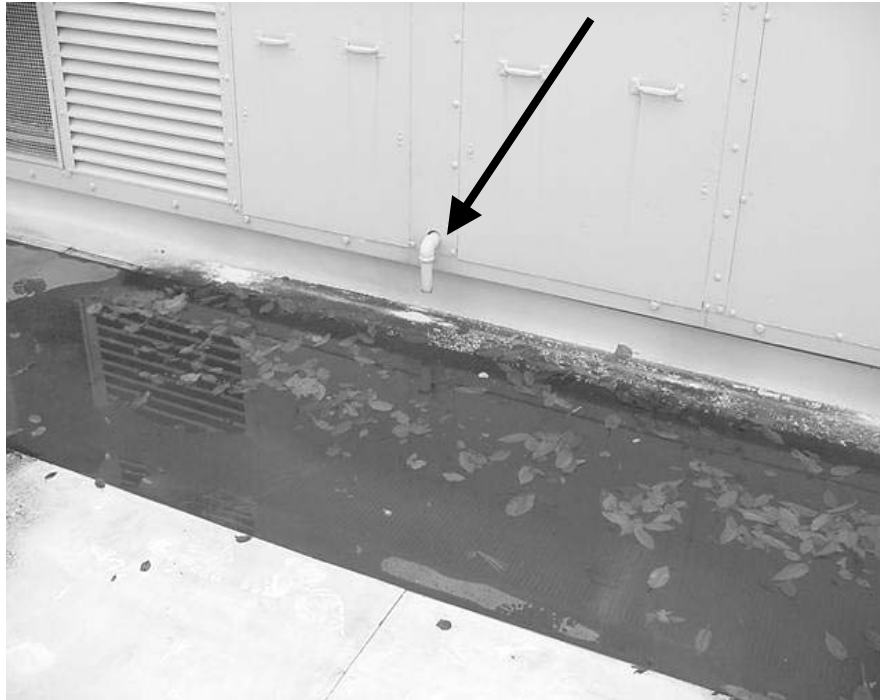
Picture 9

into the interior of the building. In addition, AHU condensation drains are located directly over pooling water (see Picture 9). Condensation drains are frequently placed in an area of the AHU cabinet that draws air into the cabinet when no water is in the pipes during the heating season. This configuration can result in moisture and odors from pooling water to be drawn into the AHU. Pooling water can also become stagnant, which can lead to mold and bacterial growth, give off unpleasant odors and provide a breeding ground for mosquitoes.

Pooling Water on Roof below Condensation Drain of AHU

6. Consider sealing the condensation drains for AHUs during the heating season. Please note that drains must be unsealed during the air-conditioning season in order to serve their intended purpose (i.e., to drain condensation. **Failure to remove condensation drain seals can result in water back up into the AHU and produce mold growth.**

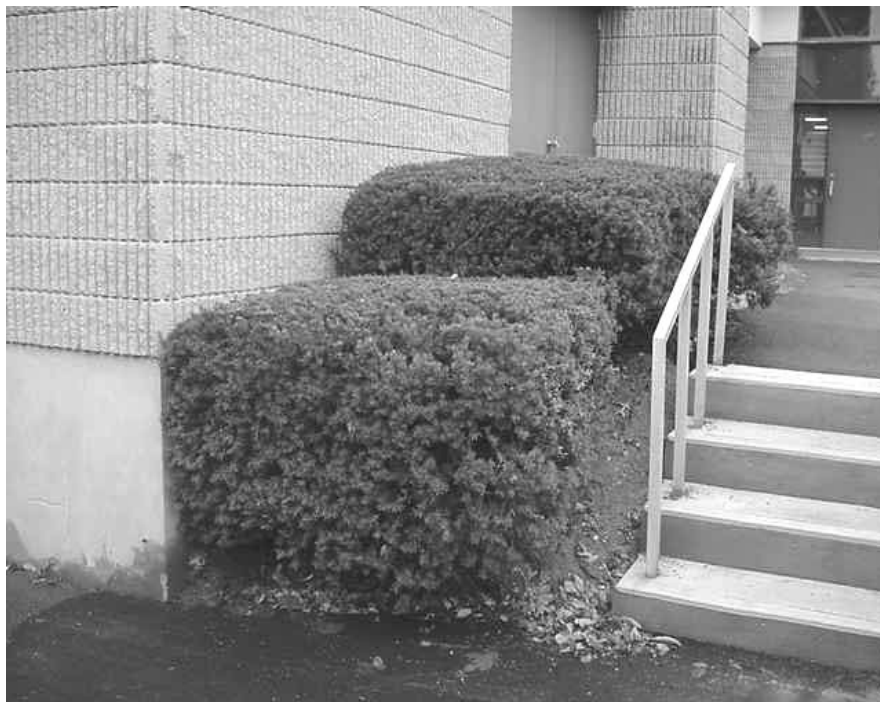
Picture 10

Shrubbery in direct contact with the exterior wall brick was noted in several areas around the building (see Picture 10). Shrubbery can serve as a possible source of water impingement on the exterior curtain wall due to the location of plants growing directly against the building. In addition, the growth of roots against the exterior walls can bring moisture in contact with wall brick and eventually lead to cracks and/or fissures in the foundation below ground level. Over time, this process can undermine the integrity of the building envelope and provide a means of water entry into the building through capillary action through foundation concrete and masonry (Lstiburek, J. & Brennan, T.; 2001).

Shrubbery In Contact With Exterior Wall

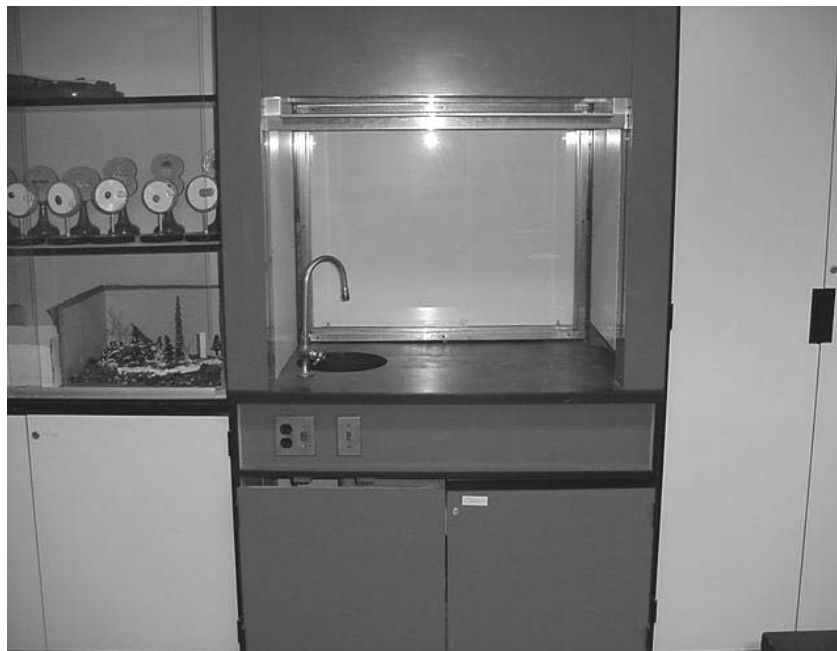
Picture 11

Several other conditions were noted during the assessment, which can affect indoor air quality. A number of the science classrooms have chemical hoods equipped with sinks (see Picture 11). It is likely that these drains have dry traps, which can allow sewer gas to back up into classrooms. In addition, several unused dishwashers were noted in science classrooms. Each of the appliances will empty water into drains, which

also should have traps. Without use, these traps can also dry out, resulting in sewer gas backup in the line. Sewer gas can be irritating to the eyes and nose.

Unused Chemical Hoods with Sinks

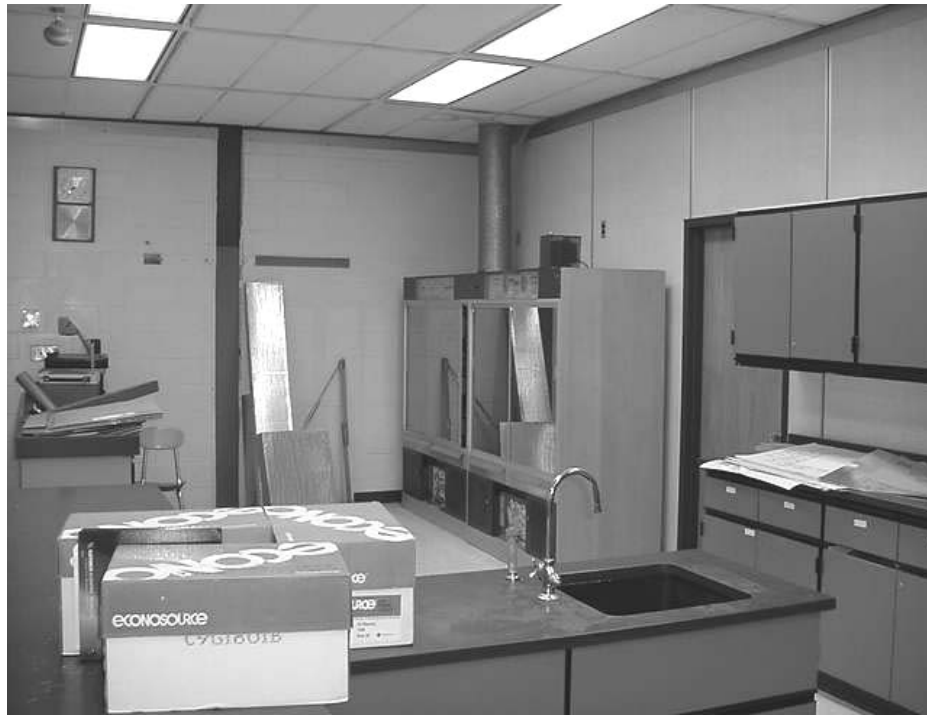
Picture 12

The science classrooms have large horticultural cabinets (see Picture 12) and display shelves (see Picture 13) that are connected to exhaust vents. Each of these units is unused and the exhaust vents appear to be inactive. Inactive exhaust vents open to the outdoors can serve as a means of drafts and allow water vapor to penetrate into the building. Abandoned exhaust ventilation equipment should have the exhaust vent rendered air and water tight to prevent moisture from breaching the building envelope, subsequently leading to uncontrolled drafts and water penetration.

Unused Horticultural Cabinets

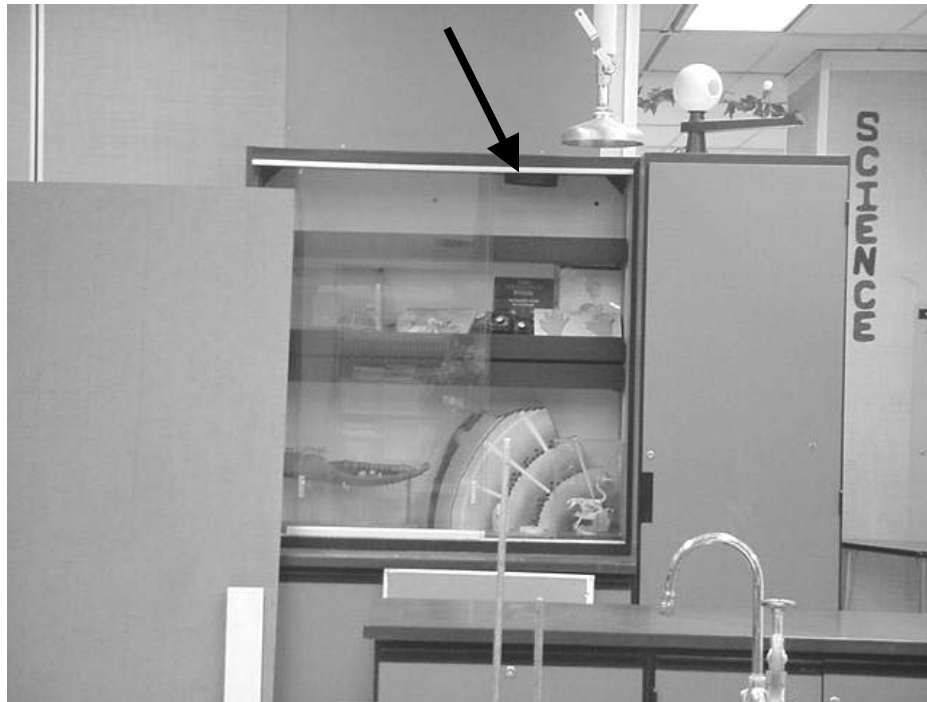
Picture 13

Exhaust Vented Display Cabinets (Arrow Indicates Exhaust Vent)

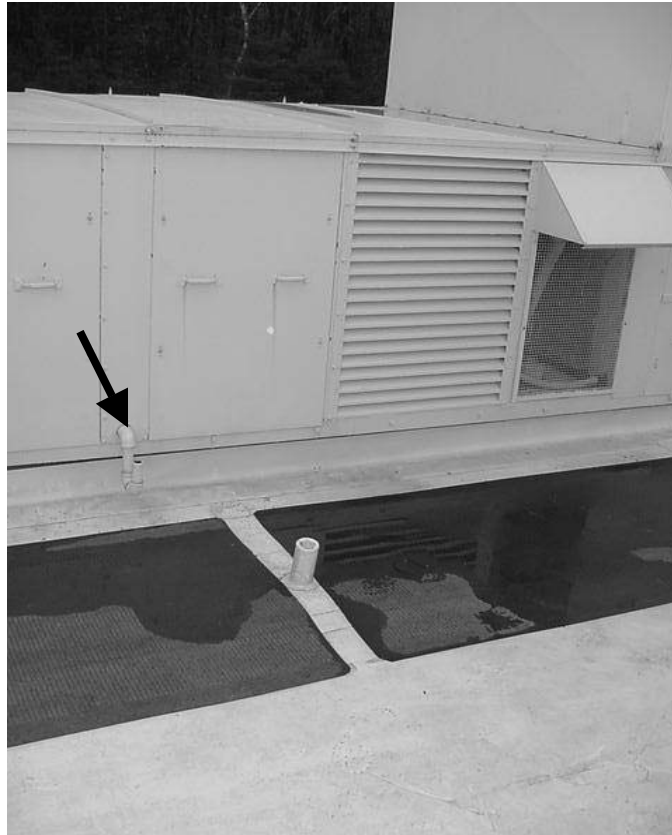
Picture 14

A sewer gas vent pipe on the roof was found in close proximity to the fresh air intake located near the AHU (see Picture 14). Sewer gas vent pipes are recommended to be at least ten feet away from ventilation fresh air intakes (SBBRS, 1997; BOCA, 1993). If the plumbing vent is located within ten feet of a fresh air supply intake, the pipe should be extended 2 feet (at a minimum) above the mechanical system intake (SBBRS, 1997; BOCA, 1993) to avoid entrainment of sewer gas odors into the HVAC system.

Sewer Gas Vent Pipe on the Roof in Close Proximity to AHU Fresh Air Intake, Note Condensation Drain

http://www.state.ma.us/dfa/pesticides/publications/IPM_kit_for_bldg_mgrs.pdf
17. Replace missing ceiling tiles, to improve exhaust ventilation and prevent the egress of dirt, dust and particulate matter into classrooms.
18. Determine whether science wing chemical hoods, horticultural cabinets, vent display cases and dishwashers will be used. Consider sealing vents at rooftop and classroom levels. Consider removing dishwashers and sealing drains. Consider sealing chemical hood drains and disconnecting water supply.
19. Examine the feasibility of providing local exhaust ventilation for the photocopier room or relocate equipment to an area with adequate exhaust ventilation.
20. Consider relocating or extending sewer gas pipes at least 10 feet above fresh air intakes located on the roof.

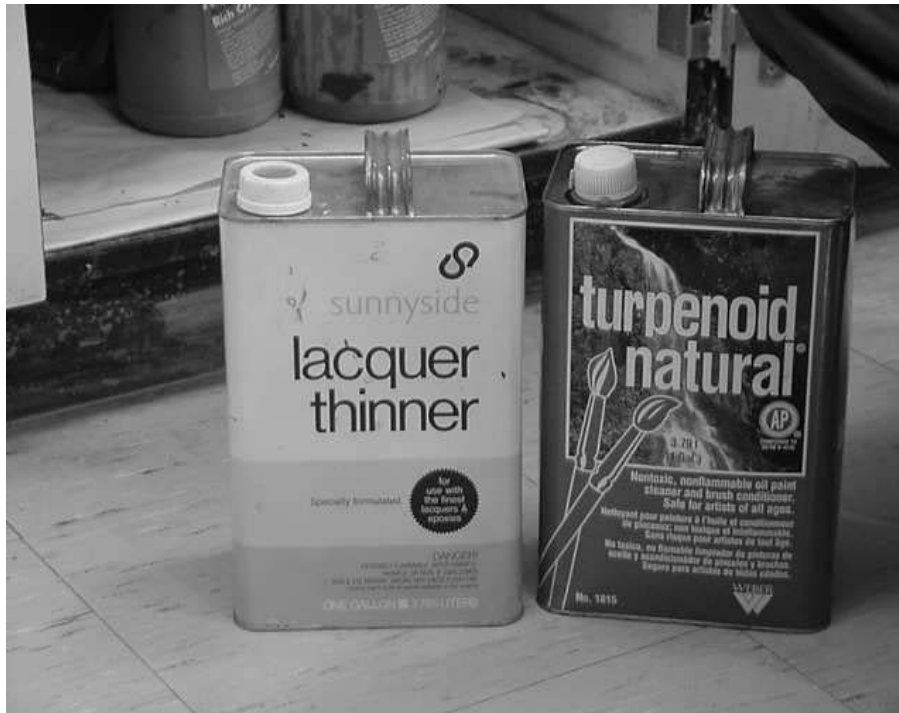
Picture 15

Paint Thinners and Turpentine Stored in a Metal Cabinet

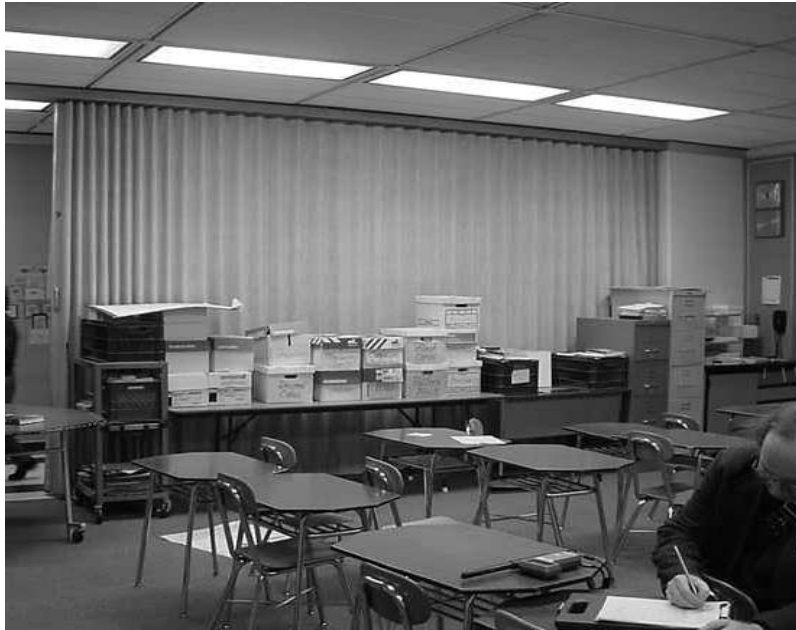
Picture 16

Concerns were raised about a proposed renovation project to remove the current moveable wall/curtains (see Picture 16) and replace with permanent walls. If the proposed walls can be built and affixed to the building frame at the current height of the moveable wall/curtains, this alteration would be expected to have minimal impact of air distribution in classrooms. If the proposed replacement walls must penetrate through the ceiling tile system to be affixed to roof trusses or support beams, this alteration may have a distinct negative impact on air distribution. The building appears to use a ceiling plenum system instead of ductwork to return classroom air back to the rooftop AHUs. In effect, the entire space of the ceiling system serves in place of ducts to remove air from classrooms. An indicator of this design is the inclusion of a window frame system that allows for radiant heating (from the sun), to heat air in the plenum (see Picture 17), presumably as an energy conservation measure. If walls are installed through the ceiling,

the additional wall space can serve to create dead spaces and possibly air pockets that would be expected to degrade the operation of the existing ventilation system. Careful consideration should be given concerning any alteration to the ceiling plenum, since air monitoring conducted by BEHA staff indicated ventilation problems with the existing HVAC system.

Moveable Current Separating Pods into Class Areas

1. Have a ventilation engineer examine the potential impact of altering the ceiling plenum if interior walls are installed through the suspended ceiling.

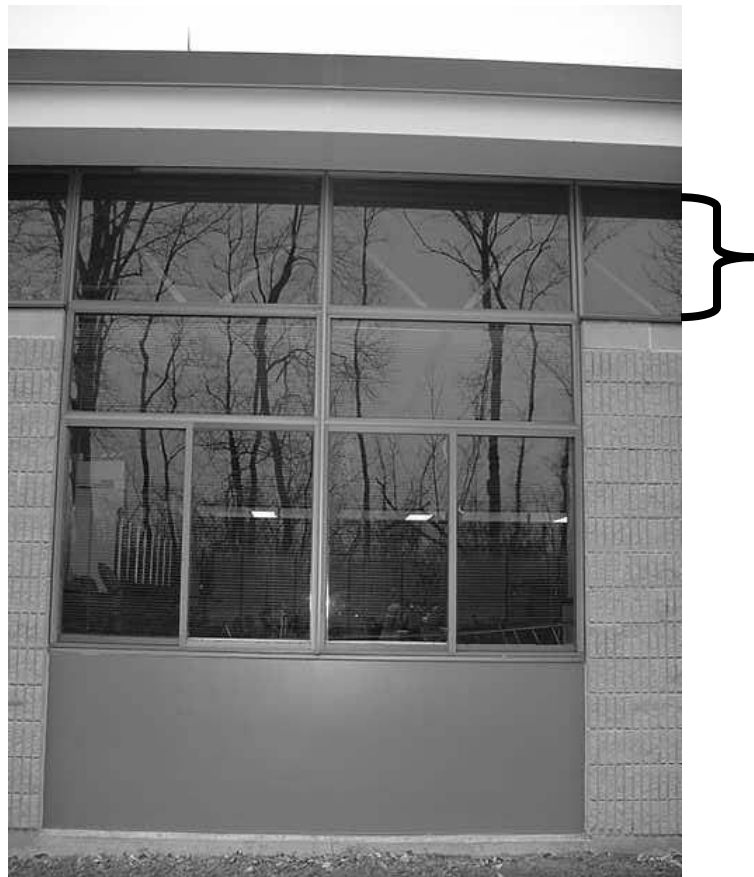
Picture 17

Glass Windows Exposing the Ceiling Plenum to Radiant Heat, Note Trusses
